Manhole Inspection Summary

Manhole # S47C__048MH

Insp Date: 7/11/08 8:56 AM

Location Address: **Fairmount**

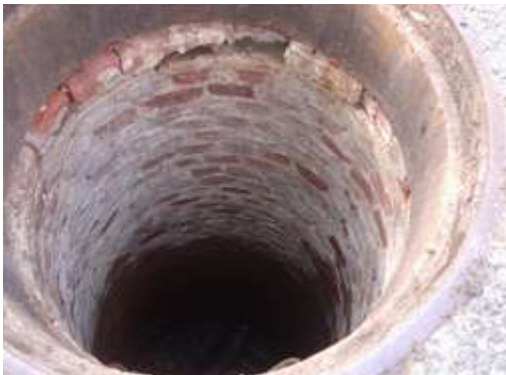
Defect 1

Condition: ☐ Sound ☐ Cracked ☐ Root Intrusion ☒ **Loose Brick** ☐ Deteriorated

Infiltration: ☐ None ☒ **Joint** ☐ Cracks ☒ **Mortar** ☐ Roots ☐ Wall

frame leaks, loose bricks

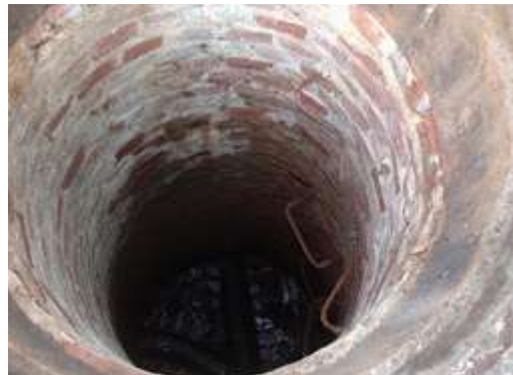
Defect 2

Infiltration: ☐ None ☐ Joint ☐ Cracks ☐ Mortar ☐ Roots ☒ **Wall**

infiltration

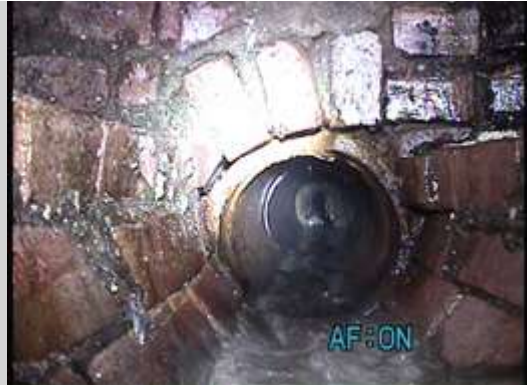
12 O'Clock Outflow

Pipe Height: **8.4** (in.) Rod and Bar (Angled)
Pipe Material: **Clay** ☐ Pipe Lined
Invert Depth: **13.20** (ft.) Flow Characteristics: **Fast**
Deposits: ☒ None ☐ Mud ☐ Sludge ☐ Debris ☐ Grease
Silt Depth: (in.) Deposits Extent:
Infiltration: **None** Pipe Seal Cond: **Sound**

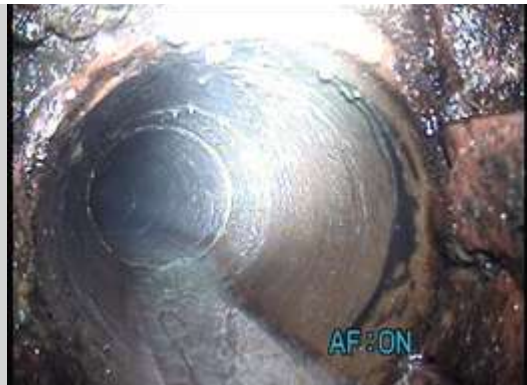
3 O'Clock Inflow

Pipe Height: **8.4** (in.) Rod and Bar (Angled)
Pipe Material: **Clay** ☐ Pipe Lined
Invert Depth: **13.10** (ft.) Flow Characteristics: **Fast**
Deposits: ☒ None ☐ Mud ☐ Sludge ☐ Debris ☐ Grease
Silt Depth: (in.) Deposits Extent:
Infiltration: **None** Pipe Seal Cond: **Sound**

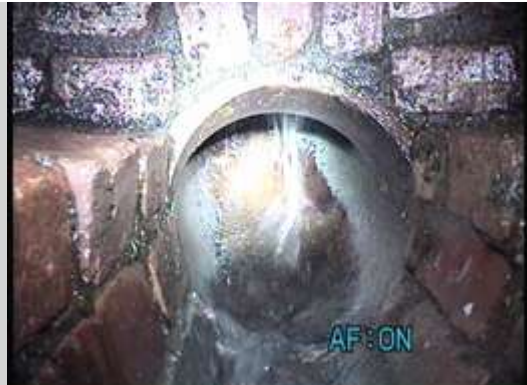
6 O'Clock Inflow

Pipe Height: **8.4** (in.) Rod and Bar (Angled)

Infiltration: **None** Pipe Seal Cond: **Sound**

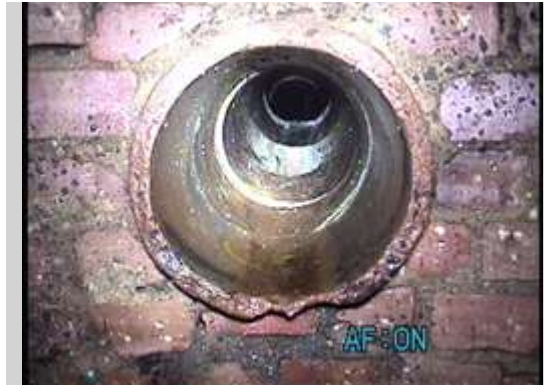
Drop In @ 6 O'Clock

Drop: **Outside** Rod and Bar

Drop Condition: **Open**
